WWT NRPs reduce riser flexjoint wear enabling successful completion of “undrillable” well in the North Sea.

Severely misaligned wellheads induce excessive side loads and flexjoint angles, accelerating wear and keyseating, ultimately rendering the well undrillable.

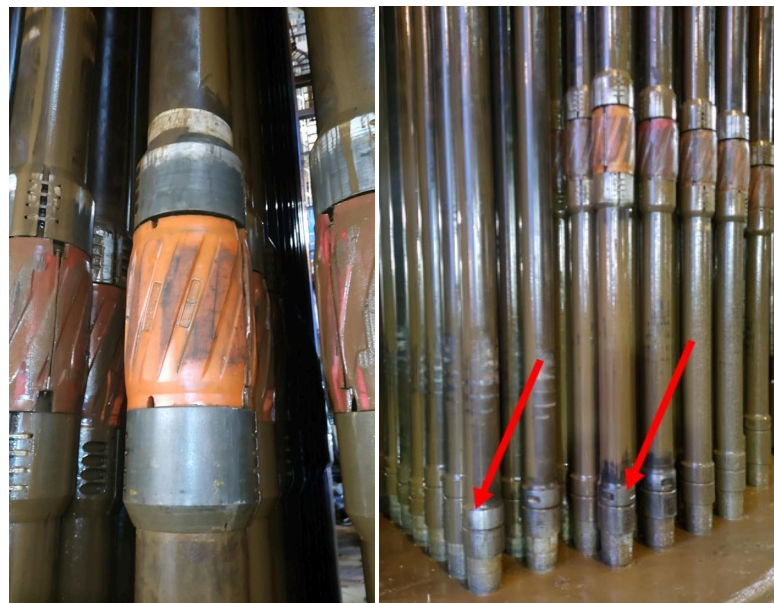
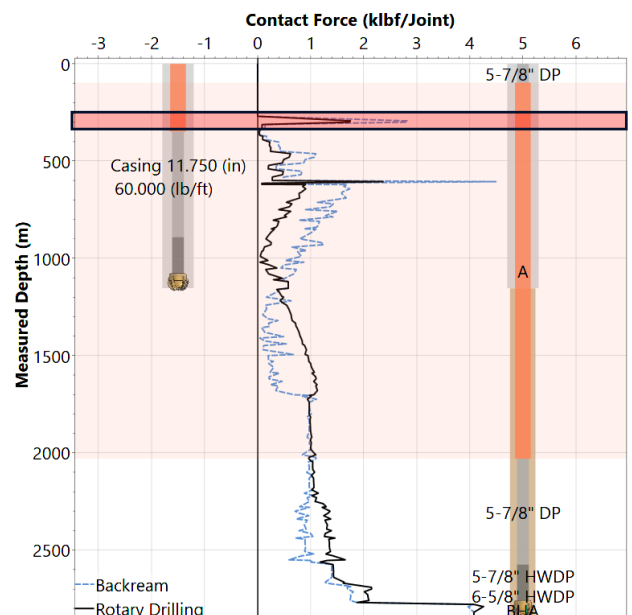
- **Unprotected tool joints showed wear and polishing compared to protected pipe. This demonstrates how the NRP eliminated tool joint contact.**
- **The flexjoint was still in good enough condition to be reused on the subsequent well without needing refurbishment. This shows that NRPs successfully protected the flexjoint.**

Final field inspection showed some wear to the lower flexjoint. However, the keyseat curvature radius is smaller than the tool joint which implies that pipe tube contact was the likely cause.
