# WWT Non-Rotating Protectors

WWT Case History – North America  
JOB # 10517 20 NRPS

## Reduced Drill Pipe Wear with WWT Non-Rotating Protectors in Lateral Wells

**Location:** Permian  
**Well Type:** Lateral  
**Objective:** Reduce Drill Pipe Wear  
**Solution:** SS3 NRP's  
**Results:** Reduced drill pipe wear and torque

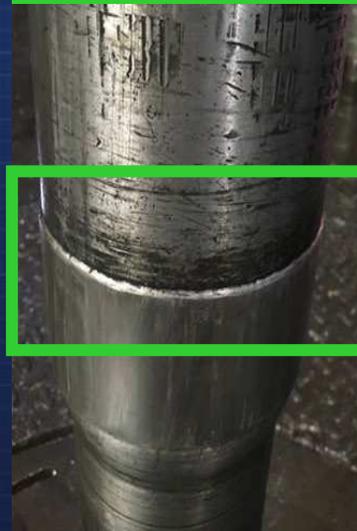
### With NRPs installed:

Hardbanding still pronounced and in similar condition prior to drilling lateral

Standard NRP placement in laterals and open hole applications is to place NRP's mid-span of the drill pipe tube to provide a centralizing effect for buckling mitigation. However, for this application WWT installed 258 4-1/2" SS3 model NRPs 4ft above the tool joint to provide standoff to eliminate tool joint wear. Since the NRPs were near the tool joint, pipe body contact became a concern because gravity would sink the middle of the pipe while laying horizontally in the lateral. WWT analyzed the pipe body contact loads to be less than 200lbf, as the NRPs would endure most of the force per joint. After reaching TD, the joints were inspected at mid span due to observing some polishing. However, as WWT predicted, no wear occurred and the exact nominal value was measured. Furthermore, 100% of the NRP protected joints were in good condition after drilling the well. The unprotected pipe resulted in polished/smear tool joints requiring re-hardbanding.

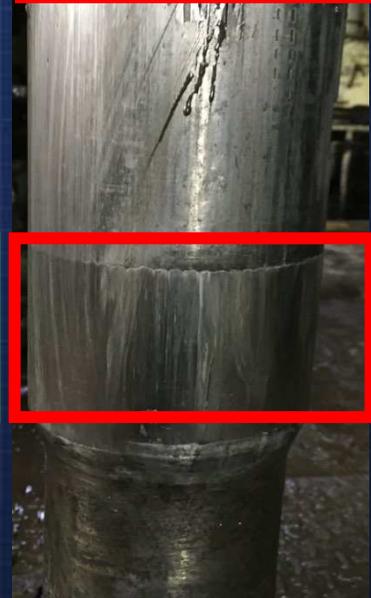
### NO NRPs installed:

Hardbanding worn flush; removing tool joint wall
